Progress Report No. 24  
For the period February 1 to April 30, 1963

## TUNGSTEN AND ROCKET MOTORS

SRI Project No. PMU 2785  
Contract NOrd-18619

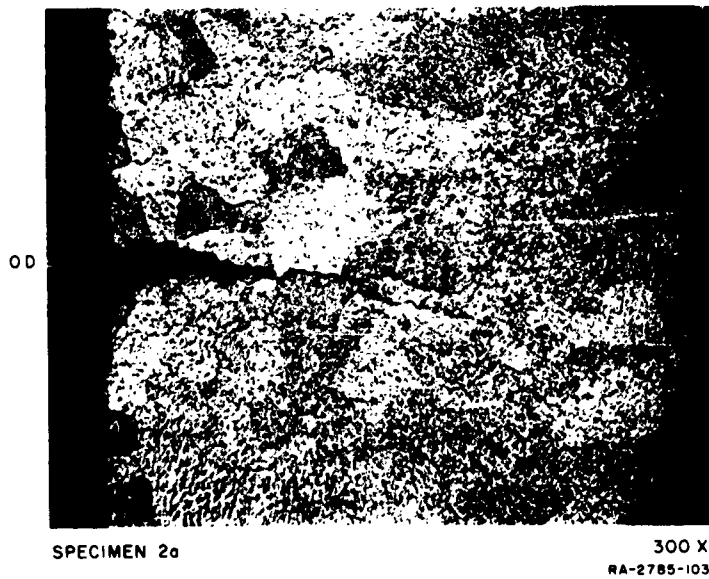
FIG. 8 MAGNIFIED RADIAL SECTION SHOWING  
TYPICAL CIRCUMFERENTIAL CRACK

Forged Tungsten -- The forged samples appeared particularly susceptible to circumferential cracking (Fig. 7, and Table II). These cracks initiated on the outer surface and propagated inward to various depths ranging from a few mils to the entire wall thickness. A photomicrograph (Fig. 8) of a polished radial section of Specimen 2a, Table II, shows a typical circumferential crack.

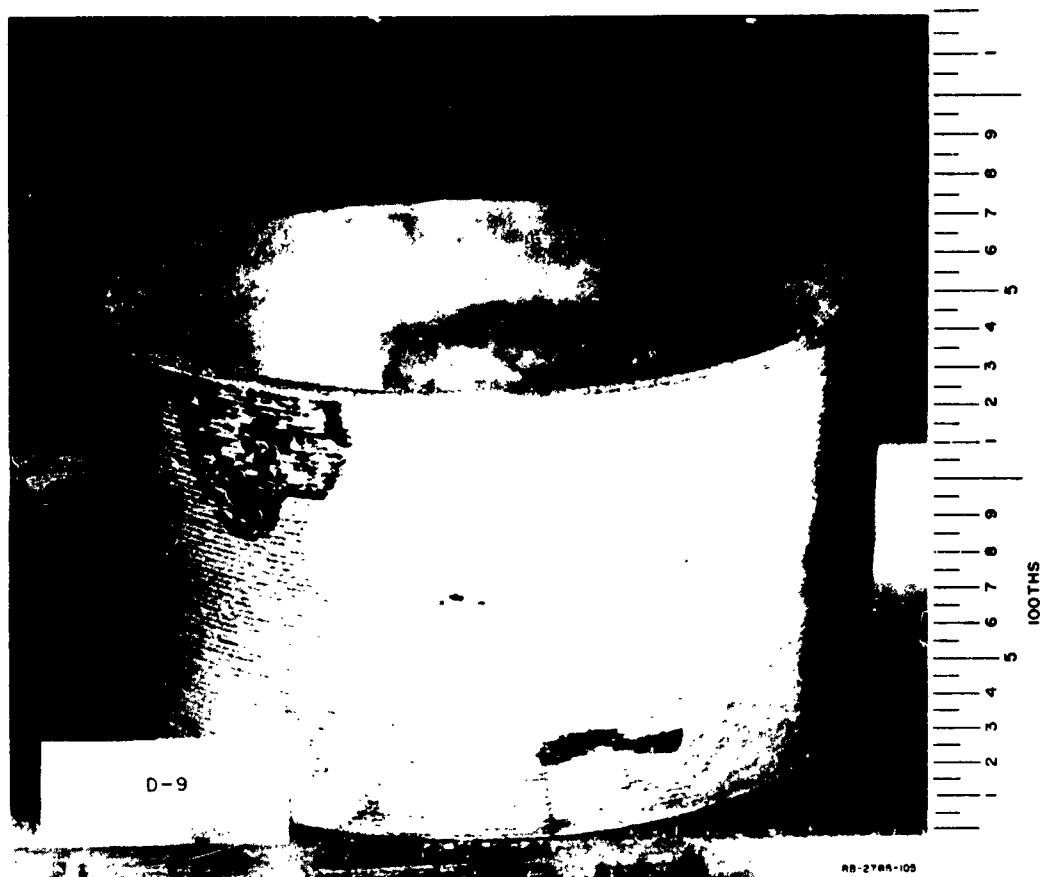
FIG. 10 SHEAR SPUN SPECIMEN (NO. 9) SHOWING  
RADIAL THERMAL SHOCK CRACK

Spun Tungsten. -- The shear spun cylinders tested were more resistant to circumferential thermal shock cracking than the forged material, Table II. No circumferential cracks were noted in any of the three "as-spun" specimens. One specimen did possess two radial cracks, however, which were quite severe. One of these cracks propagated through the entire wall thickness, Fig. 10.

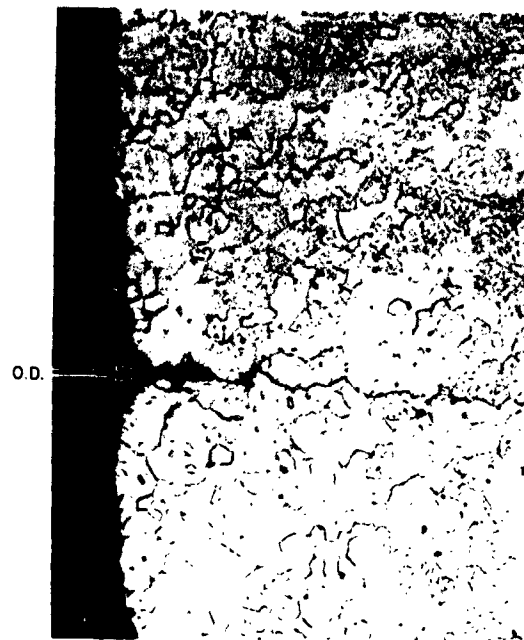
RADIAL SECTION

TANGENTIAL SECTION

FIG. 12 SECTIONS OF FORGED TUNGSTEN SPECIMEN (No. 5) SHOWING CIRCUMFERENTIAL THERMAL SHOCK CRACK

The wrought structures of the spun tungsten and forged tungsten specimens were examined metallographically. The spun material (Fig. 11) had a pronounced grain elongation parallel to the cylinder axis, whereas the forged tungsten had a relatively homogeneous structure with possibly a slight grain elongation in the circumferential direction (Fig. 12). In each case thermal shock cracking occurred predominantly in a direction parallel to the grain flow, i.e., radially in the spun
